# **REINFORCED SLOPE WITH GEOGRIDS**

**Final Report for  
Iowa DOT Project HR-548**

**GREENHILL ROAD BIKEWAY  
WATERLOO, IOWA  
PROJECT IX-6585(9)--79-07**

By  
Jeff Bales  
Associate Engineer  
319-291-4312  
City of Waterloo Engineering Department  
Waterloo, IA 50703

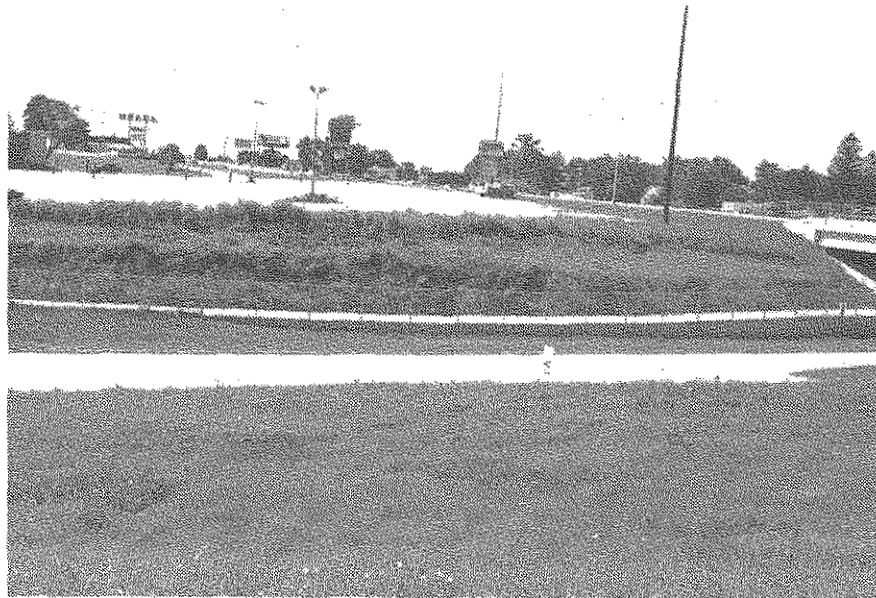
**PHOTO "B"**

Greenhill Road Bikeway South of University Avenue Bridge.

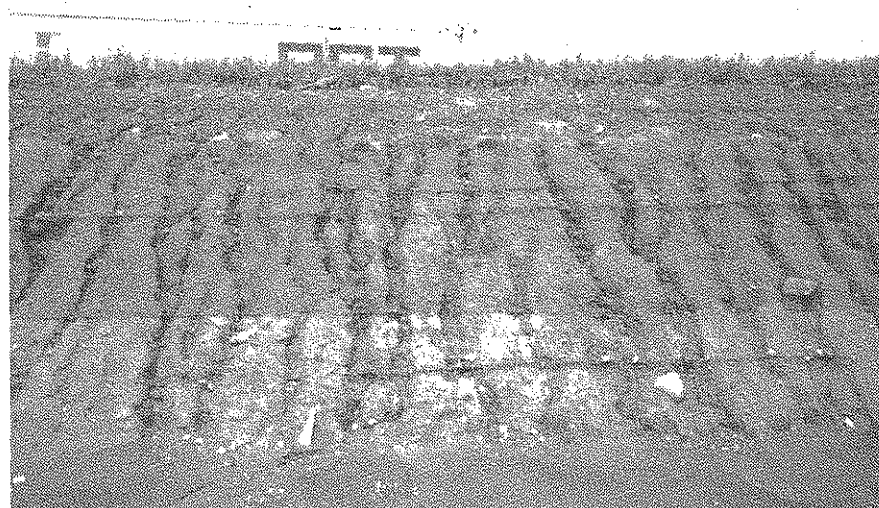
**PHOTO "D"**

Imported Blue Glacial Till material placed on top of existing clay material.  
Note protruding edges of geogrids.

Several areas of organic material (topsoil) were found within the existing soil (see Photo C) that had been planned to be removed and recompact into the reinforced slope. This material was unsuitable for reinforced slope construction. Blue Glacial till material was imported and placed (see Photo D).

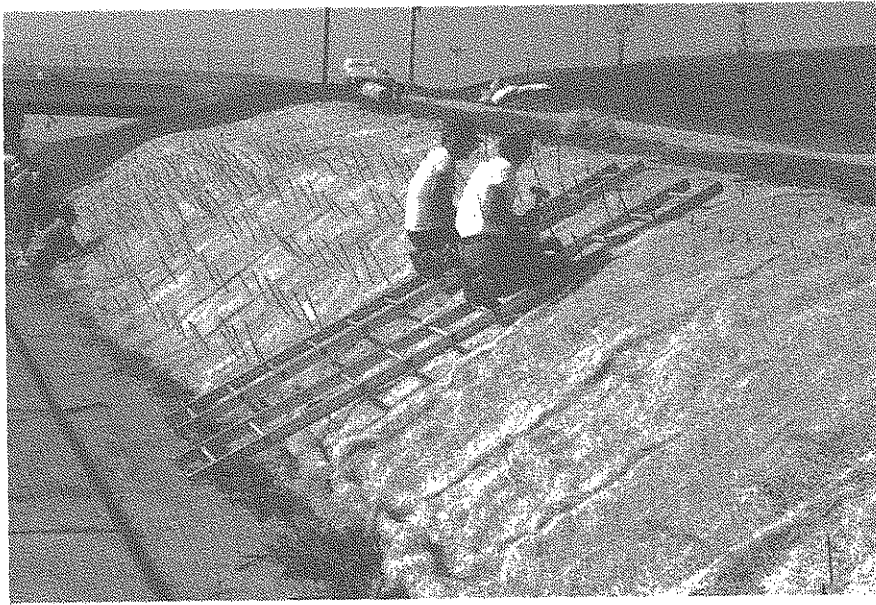
**PHOTO "E"**  
Anchor pin placement through wood excelsior mat

Standard length pins per Iowa DOT Design Office were too short to penetrate through topsoil and into reinforced slope. Photo E shows anchor pins being hammered through excelsior mat into ground.

6. Increase length of anchors for wood excelsior mat, revise seed mixture, increase waterings and increase area.

Pins, Seed mix, waterings and area - 500.7 squares at \$45.00 = \$22,531.00 Increase

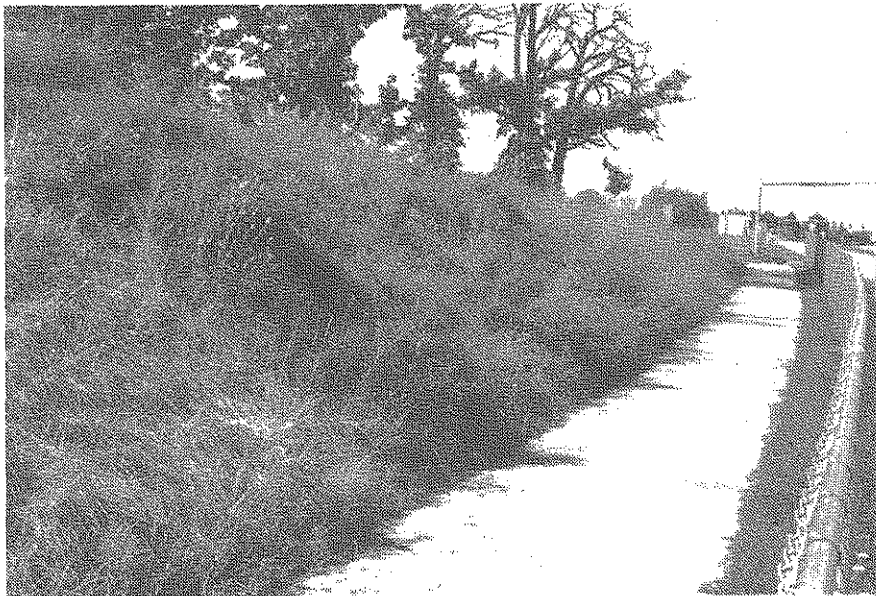
**PHOTO "F"**  
Reinforced slope vegetation

Substituted perennial rye for creeping fescue in seed mixture to promote the root structure of the vegetation (see Photo F).

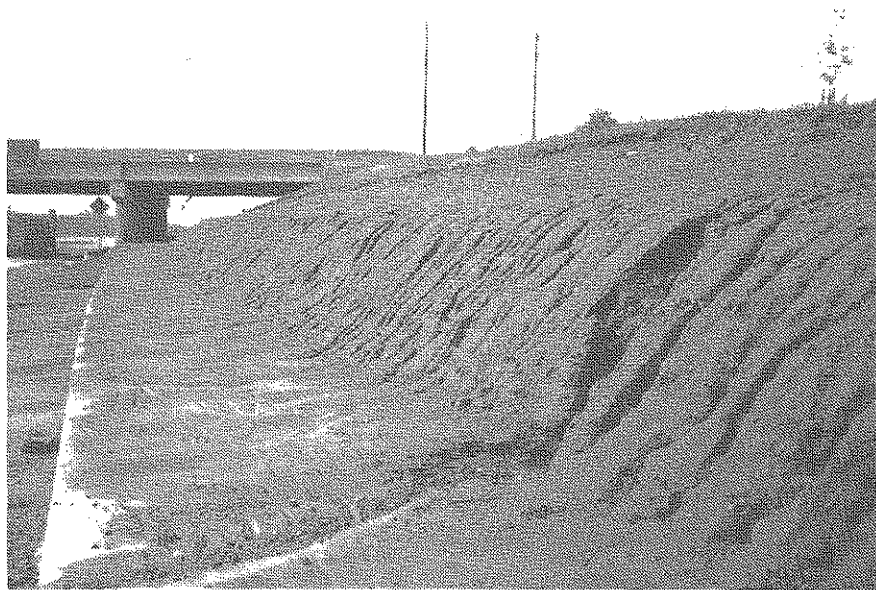
**PHOTO "I"**

These efforts were taken in order to provide a better bond between the topsoil and the till material in the reinforced slope and to promote the growth of vegetation to reduce the erosion of the topsoil. Photos H and I indicate the magnitude of erosion that happened on the bare reinforced slope. The slope had to be regraded and then the topsoil was placed (see Photo J) and seeded. The surface of the 1:1 reinforced slope was also scarified horizontally in some areas to promote bonding of topsoil. Eventually, it took three seedings to establish a rich enough vegetation. Photos K and L were taken in September of 1993 after the third seeding had taken hold.

May 1991 – Before topsoil was placed—erosion or washout due to run-off—needed to be regraded and topsoil placed and seeded.

A downside to this project was the erosion susceptibility of the reinforced earth slope before permanent vegetation took hold. Interim erosion control measures might need to be considered in future projects.

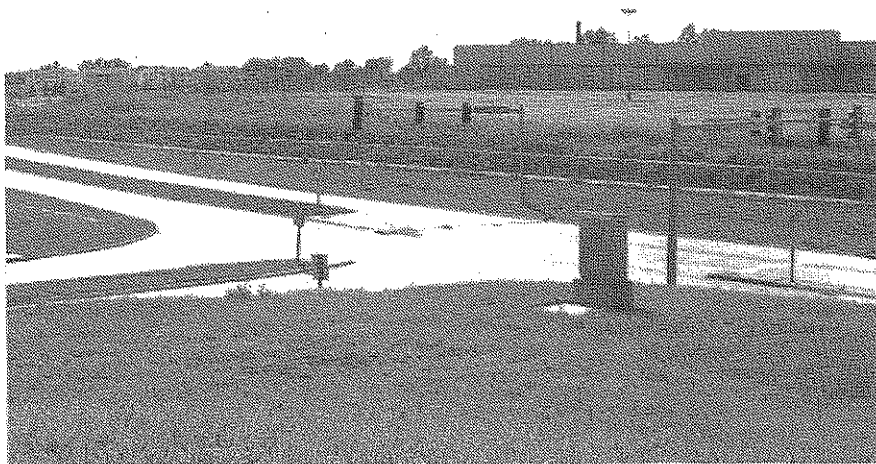
**PHOTO "K"**

September 1993 Reinforced slope vegetation after third seeding.

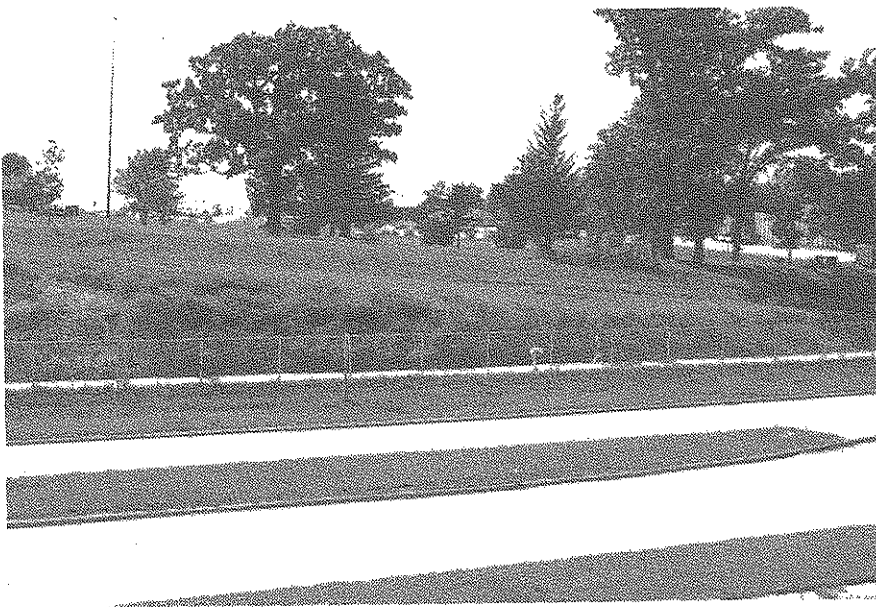
**PHOTO "L"**

September 1993 Reinforced slope vegetation after third seeding
